Docket No. 217 – Development and Management Plan Inspection

Northeast Utilities Service Company Certificate of Environmental Compatibility and Public Need for the construction of a 345-kV electric transmission line and reconstruction of an existing 115-kV electric transmission line between Connecticut Light and Power Company's Plumtree Substation in Bethel, through the towns of Redding, Weston, and Wilton, and to the Norwalk Substation in Norwalk, Connecticut.

Date: August 4, 2005

Location: Transition Stations (Hoyts Hill, Archers Lane)

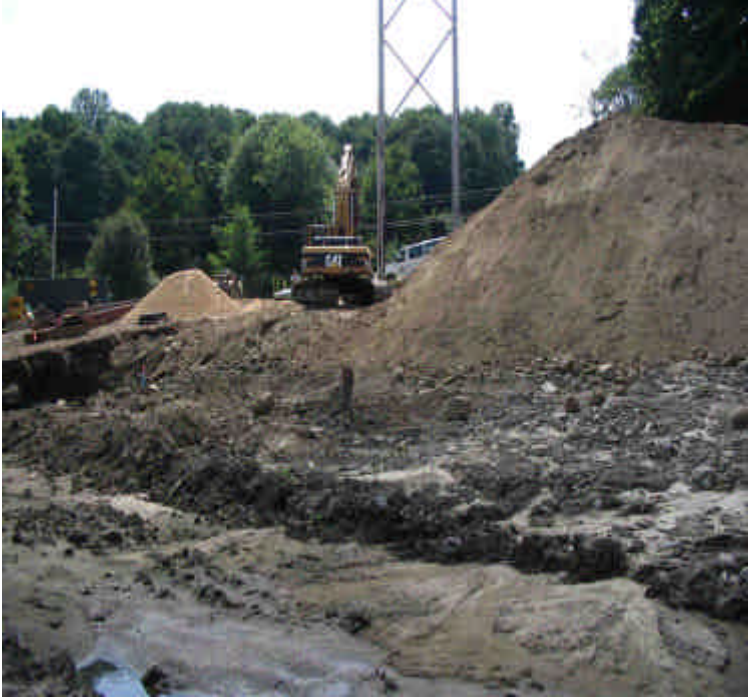
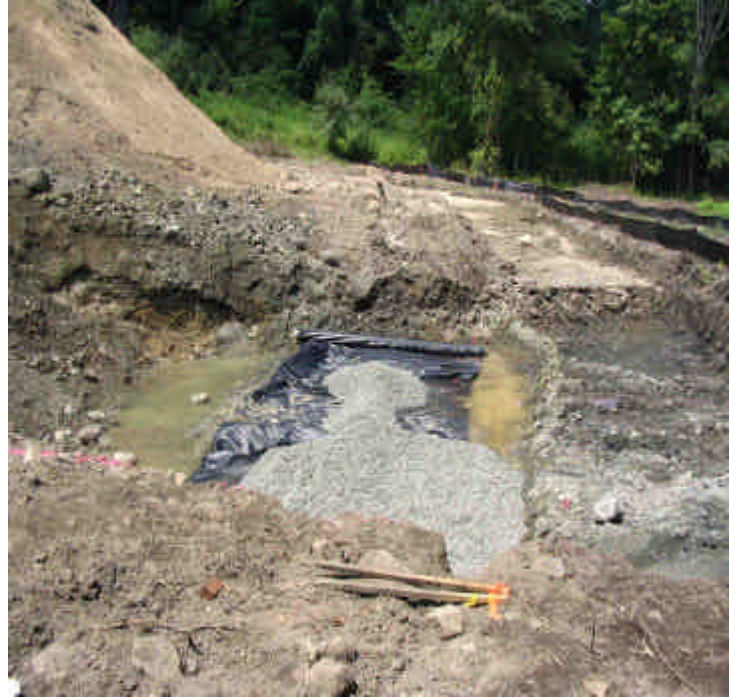
Hoyts Hill Transition Station: Overall view of the earthwork occurring at the site on the left and a view of an excavation in preparation for foundations on the right. (8/4/05)

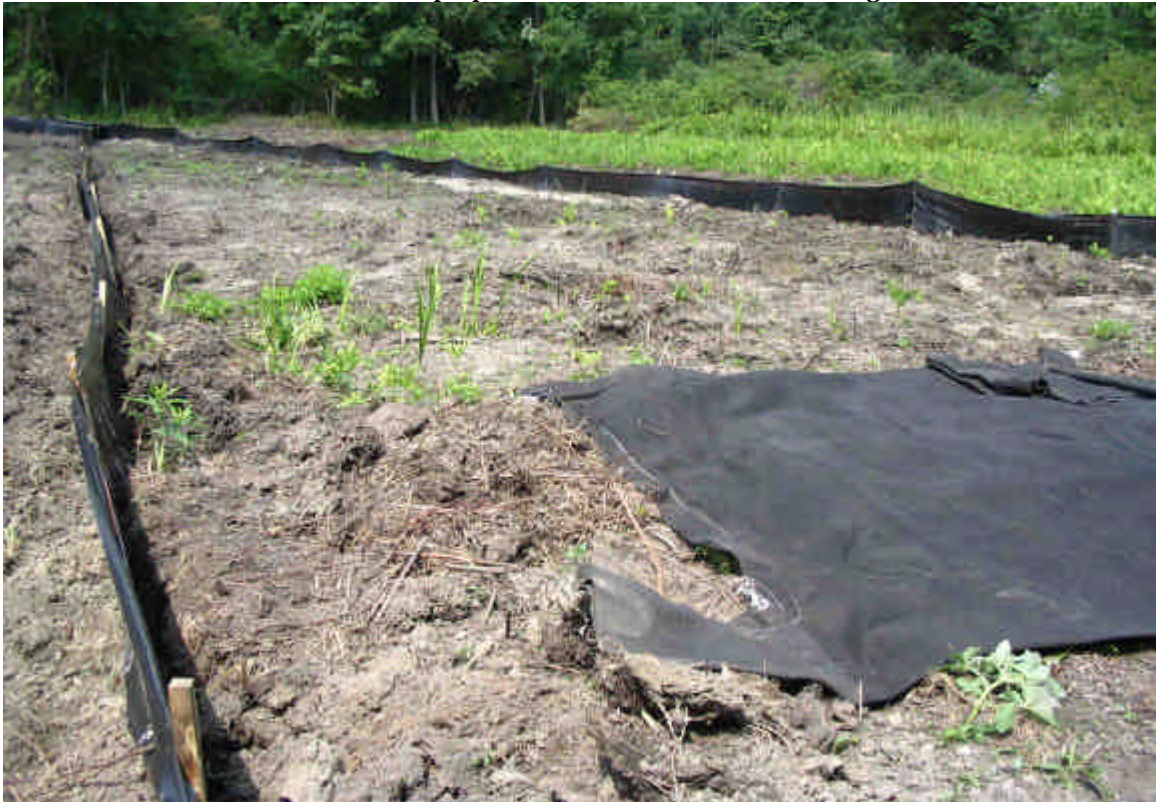
The second row of silt fence was installed as requested and the original row has been repaired. This provides an additional barrier to the adjacent wetland from the earthwork. The filter bag for dewatering was placed within this area as it is one of the best fits for the site. (8/4/05)

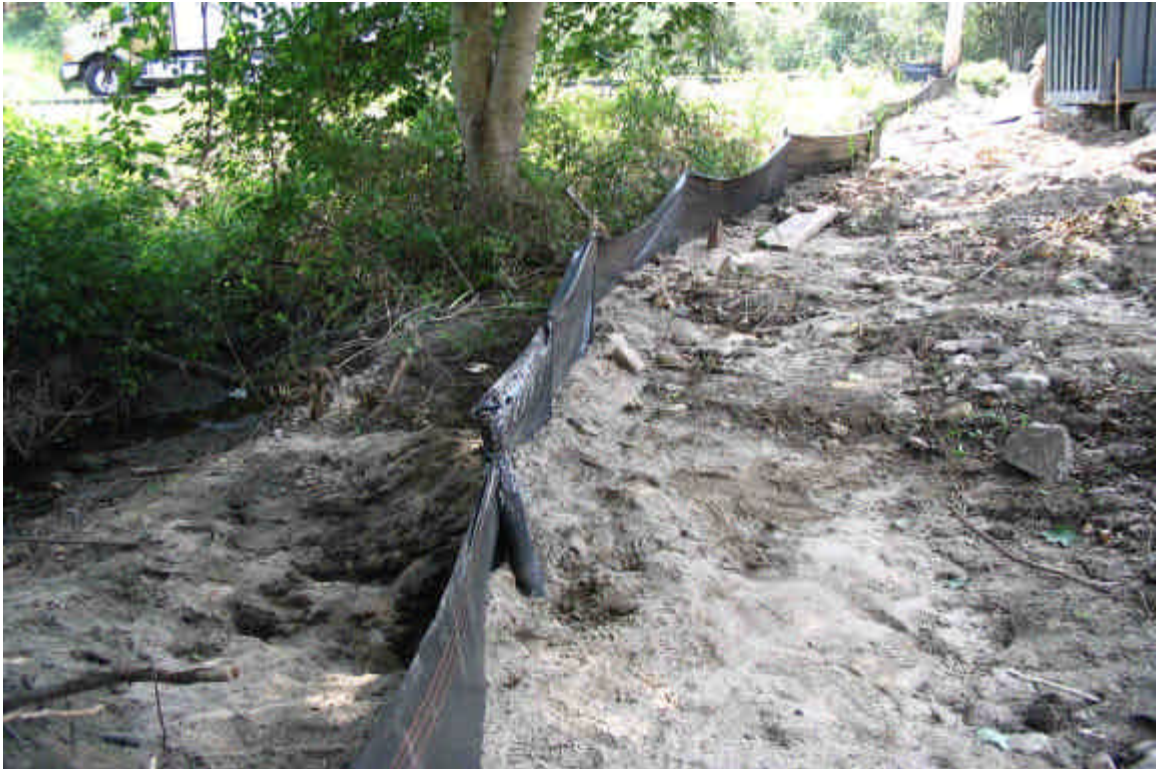
This area behind the fence was disturbed with the installation of the barrier. It will be mulched with straw and allowed to revegetate. (8/4/05)

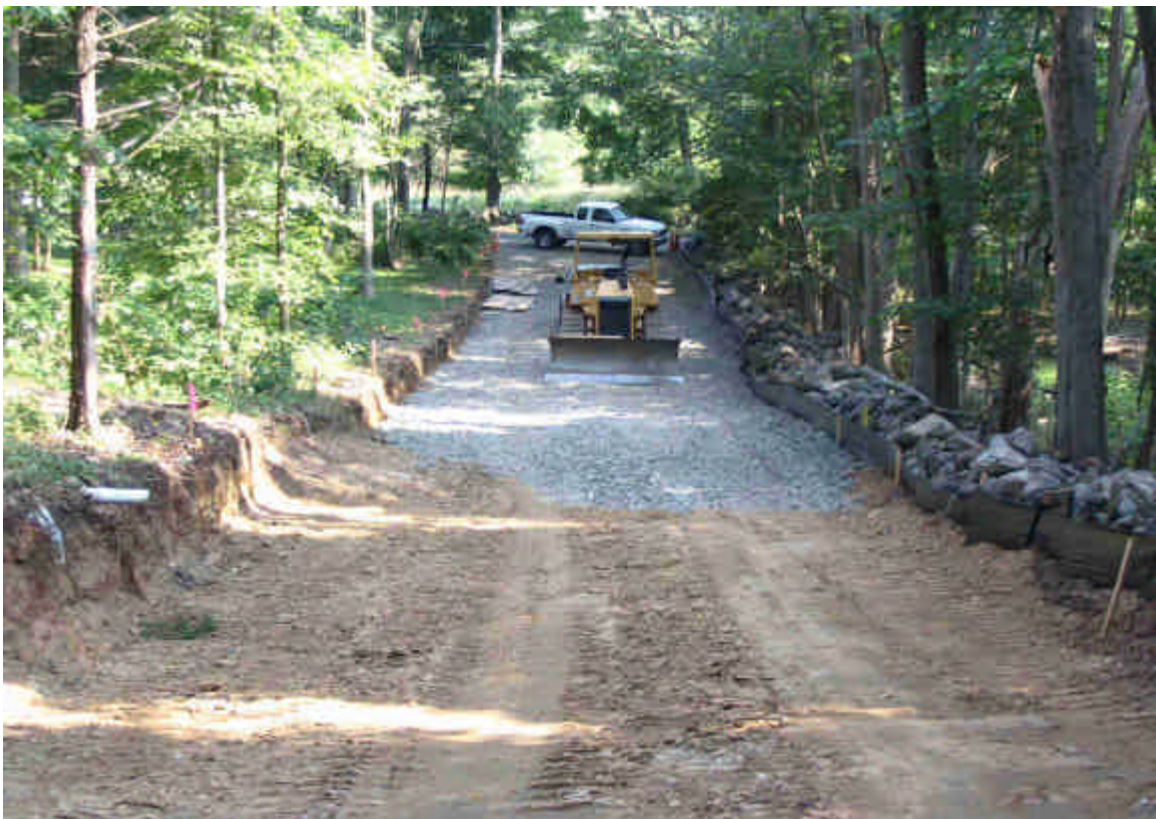
Archers Lane Transition Station: Additional view of the access road with the lengthened construction access pad. There were no noticeable repairs to be made to the silt fence. (8/4/05)
